NEW MEXICO
ENVIRONMENT DEPARTMENT

Ground Water Quality Bureau

Memorandum

Subject: Pre-CERCLIS Screening Assessment of the Section25 Shaft Mine (Grants Mining District), McKinley County, New Mexico:
Further Investigation under CERCLA Recommended

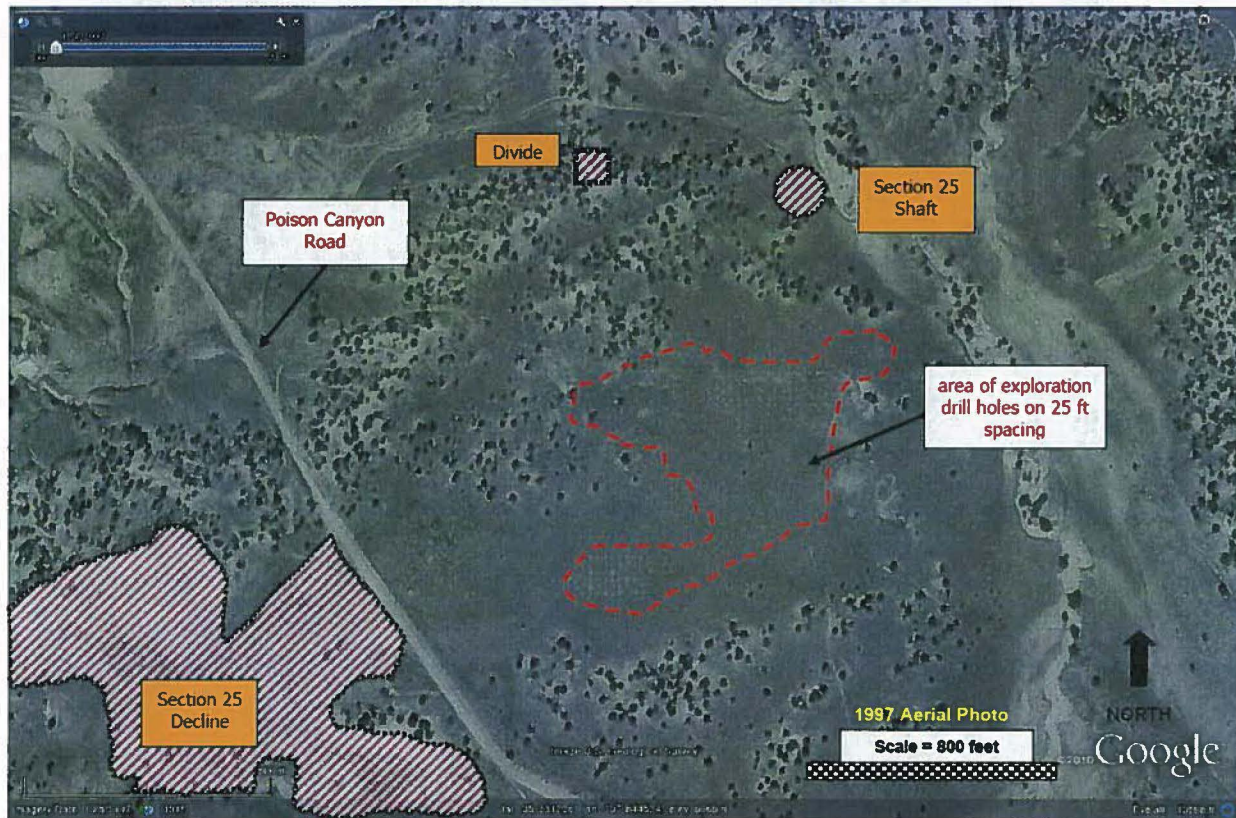
Figure 6. 1997 Google Earth location map of the Section 25 Mines showing no residential structures in the area near the mine sites.

Figures 6, 7, and 8 present a Google Earth location map for the Section 25 Mines during the years 1997, 2005, and 2009 (Attachment A). Figure 6 shows in 1997, there were no residential structures and no new roads in the vicinity of the Section 25 Shaft Mine. Figure 7 shows in 2005 there is one new residential structure and one new road approximately 1,111 ft. southwest of the Section 25 Shaft Mine. Figure 7 also shows a large rectangular feature that is assumed to be the disturbance of ground surface from the construction of a fence around the property containing the new residential structure, the Divide Mine, and the Section 25 Shaft Mine. Figure 8 shows in 2009 there are two more new residential structures and two new roads in the vicinity of the Section 25 Shaft Mine. In Figure 8 one new residential structure is approximately 160 ft. northwest of the Section 25 Shaft Mine. Figure 8 shows another new residential structure and road that are approximately 1,160 ft. south of the Section 25 Shaft Mine.

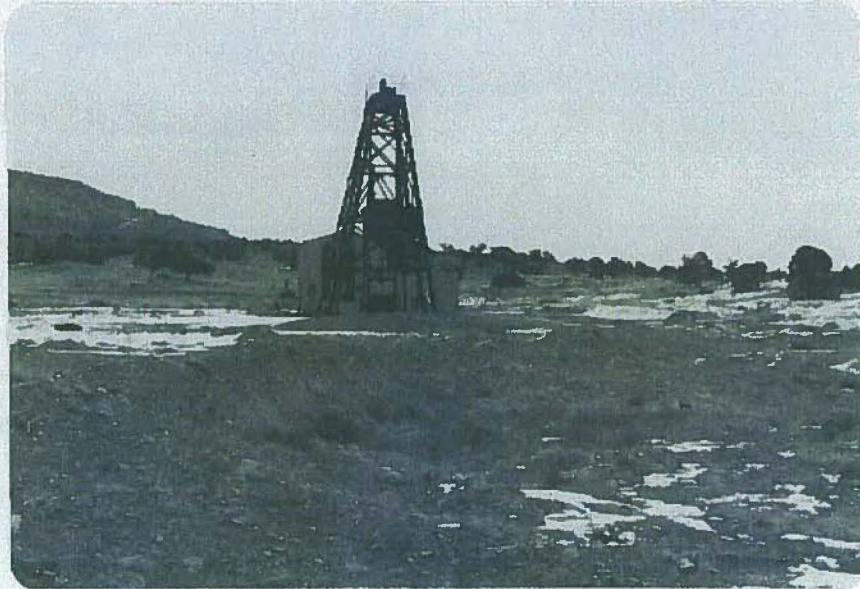
Photo (a) Looking north at head frame and hoisting shed at Sec. 25 shaft; note small dump area in foreground. Shaft is about 35' high.

The Section 25 Shaft Mine was visited, photographed and described by Anderson in 1980 (Ref. 2). The Section 25 Shaft Mine featured a vertical shaft with a 35 ft. high head frame and an 18 ft. X 32 ft. hoisting shed (See photographs in Attachment B). The total depth of the mine was possibly a maximum of 120 ft. based on the estimated length of cable wrapped around the hoisting spool at the time of the Anderson visit (Ref. 2.). Mine waste rock dump areas were noted north and south of the head frame with the largest workings on the north side that possibly extended past the Section 25 boundary and into Section 24. The north side waste rock area included an 8 ft. X 20 ft. concrete slab and possibly covered a ventilation shaft (Ref. 2).

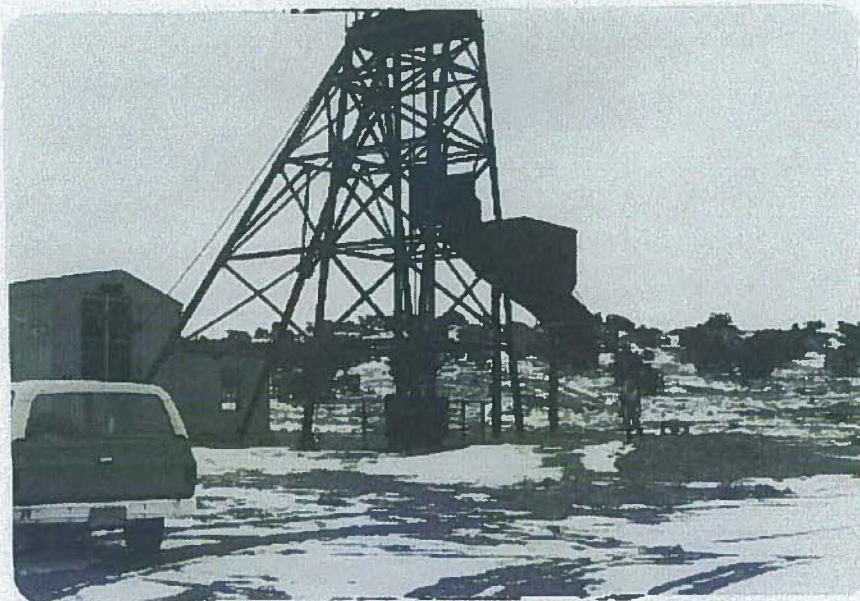
Photo (b) Close up of head frame, showing the skip suspended over shaft at ground level, and small ore pile lying below chute where person is standing.

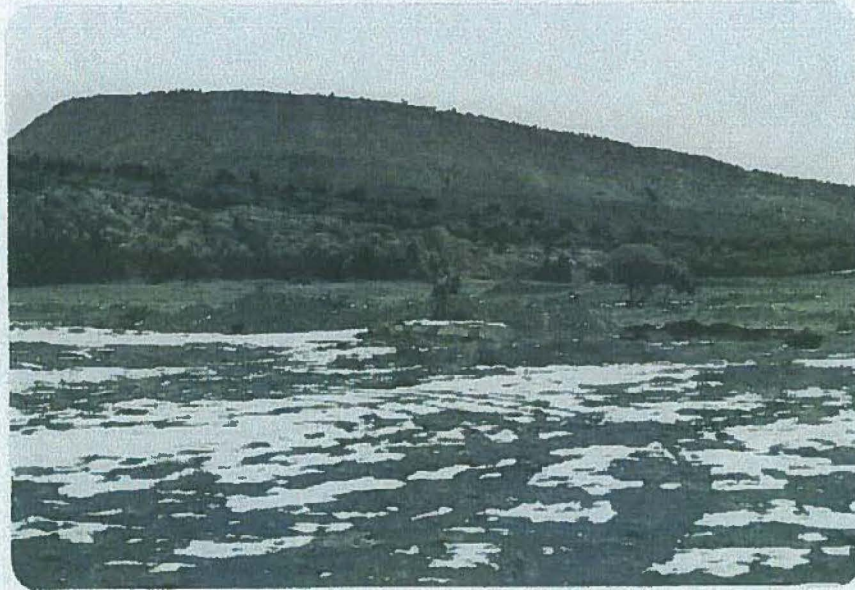
Photo (c) View to northwest of shaft and head frame, showing an extensive mine dump area that continues into the background, and an 8' x 20' concrete slab covering a small ventillation shaft and/or escapeway; person is standing on concrete slab.

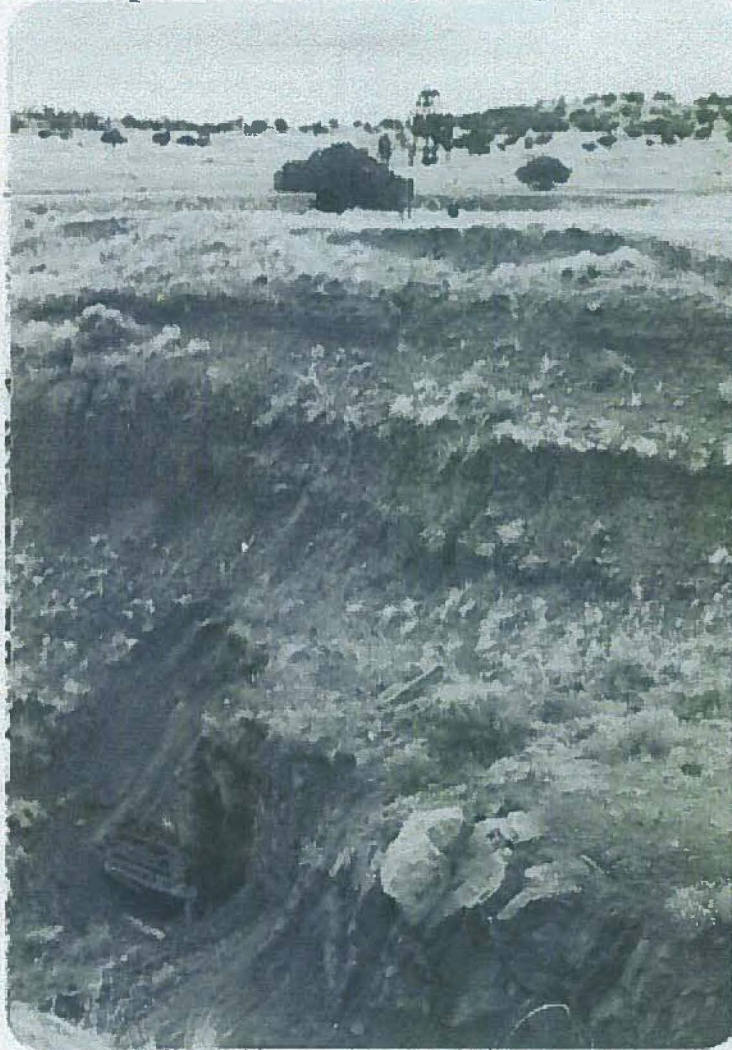
Photo (d) Looking northward into box cut with decline driven eastward at bottom. Close-up of decline is given on next page. Note section 25 head frame in background 1,000' away.

Based on the photographs in the 1980 Anderson report, the Shaft was located northeast of Poison Canyon Road (also know as Haystack Road), and it was along a north-south line with the Section 25 Decline Mine (See photographs in Attachment B). MMD's information describes the disturbed area for the Shaft as 18.58 acres (Ref. 3). The Anderson report describes the mine and number for the Site as, "Section 25 Shaft, NM-149-4-18" on page 141 which is included in the MMD data for mine identification number NMMK0215 (Ref. 3 and Ref. 4). There is no Section 25 Shaft Mine described in the information in the MMD Exempt file for Abandoned Uranium Mines (Ref. 4).
